Enhanced Preliminary Assessment Report:

New Britain Army Housing Units
New Britain, Connecticut

October 1989

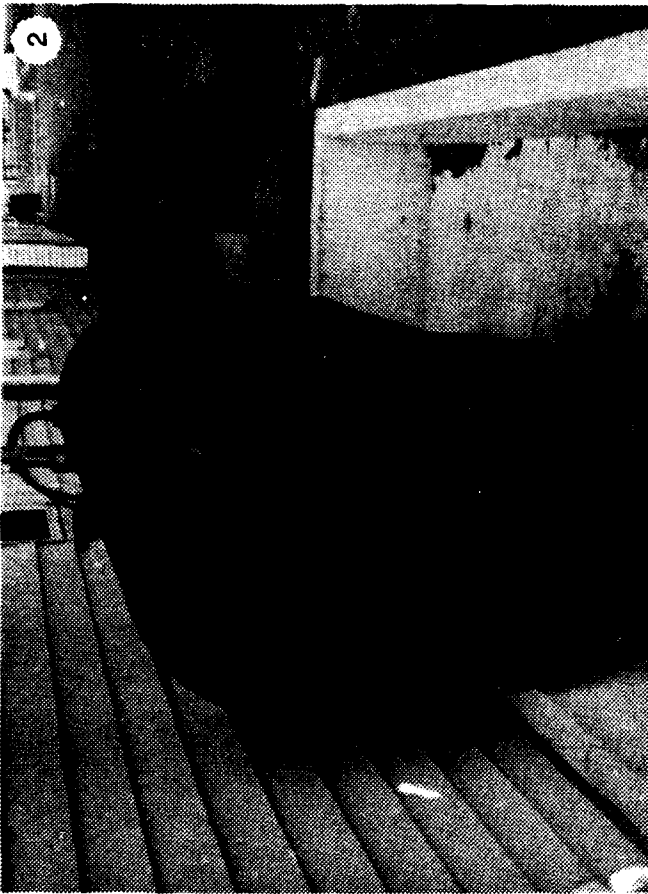
1. A view along Kulper Road toward Halsey Road in the distance; the electrical transformer atop the utility pole is located in front of unit #11; transformers are the responsibility of the New Britain Power Company.
2. Above-ground fuel tank in its concrete containment box at rear of unit #14, on Green Street; end seam of the tank shows considerable rusting.
3. Private residence next door to unit #28, on Kulper Road; similar private residences surround the housing area; partially framed on the right is an electrical transformer atop a utility pole, which is in front of unit #19 on Kulper Road; transformers at this site are owned by the New Britain Power Company.
